ASSESSMENT OF DAM SAFETY OF COAL COMBUSTION SURFACE IMPOUNDMENTS FINAL REPORT

**CPS Energy
J.K. Spruce Power Plant
San Antonio, Texas**

Prepared for
*U.S. Environmental
Protection Agency
Washington, D.C.*

February 2014
Revised May 2014
Revised June 2014

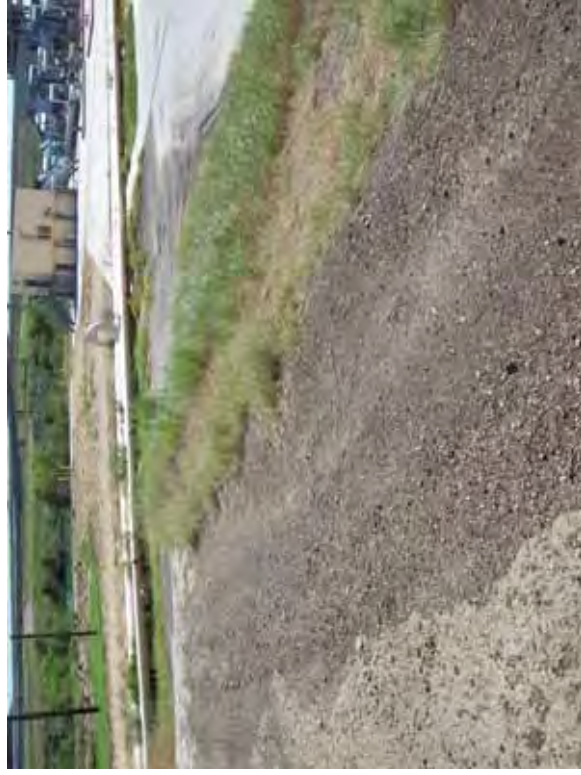
Photo 49: Exterior slope at southwest corner, looking southwest.

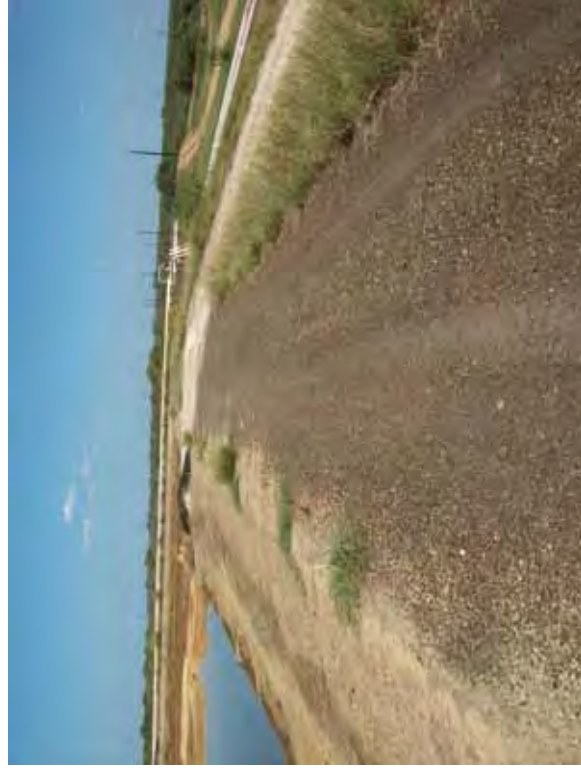
Photo 50: South embankment crest, looking east.

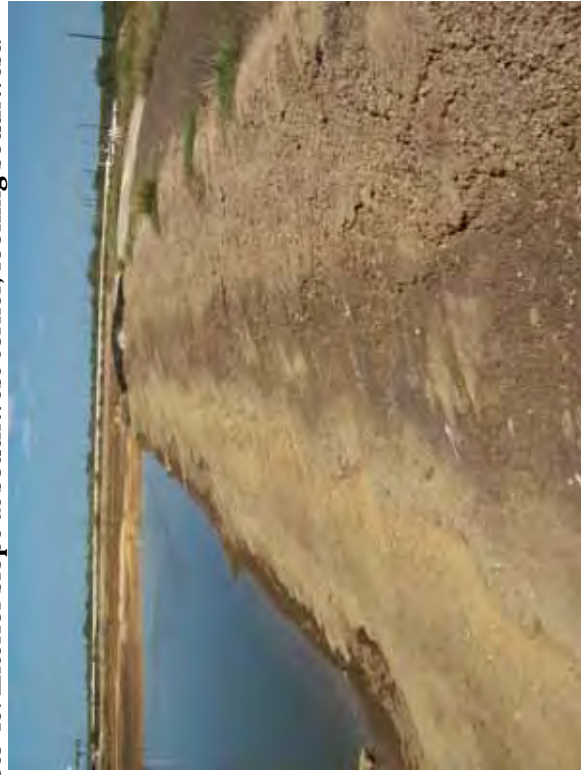
Photo 51: South embankment interior slope, looking east.

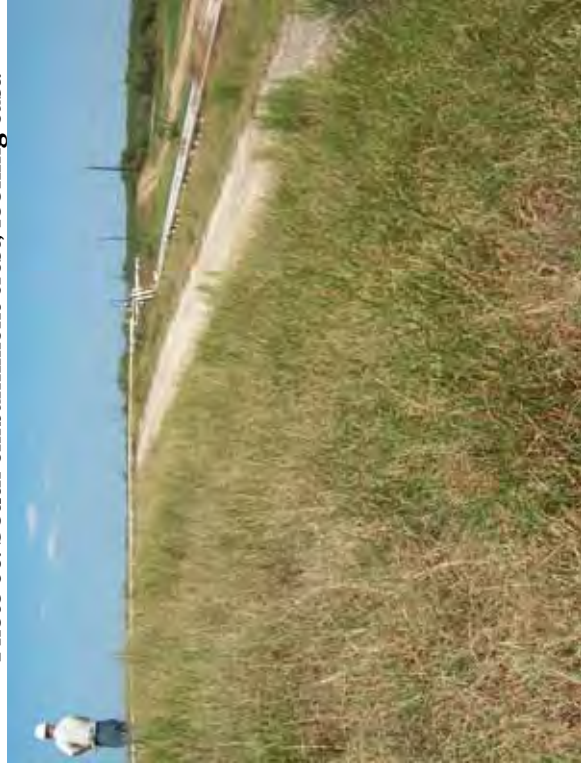
Photo 52: South embankment exterior slope, looking east.

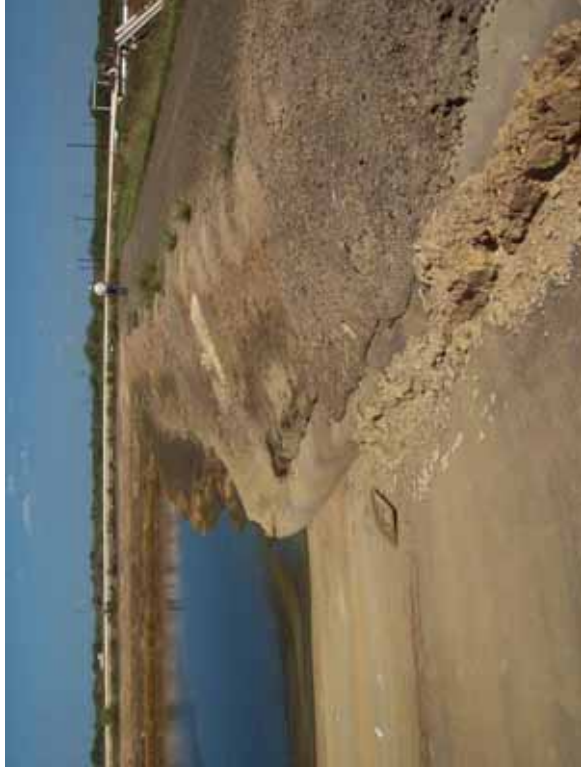
Photo 53: South embankment interior slope, looking east.

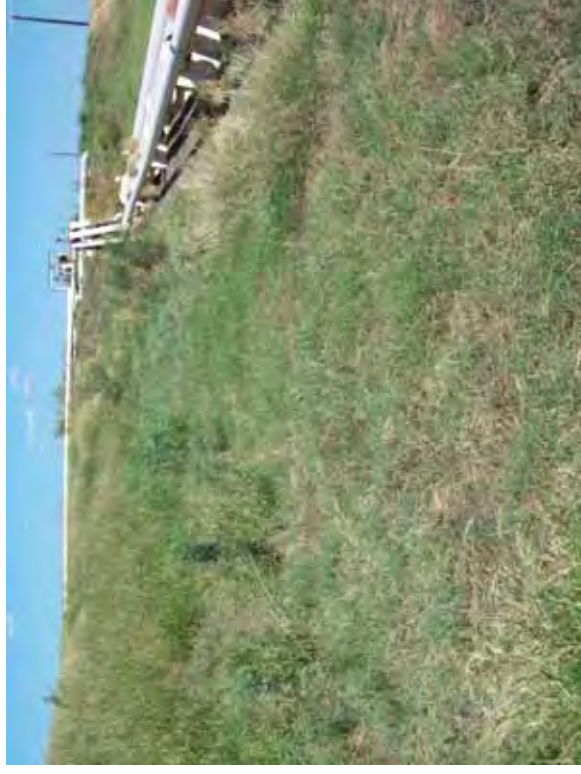
Photo 54: South embankment exterior slope, looking east.

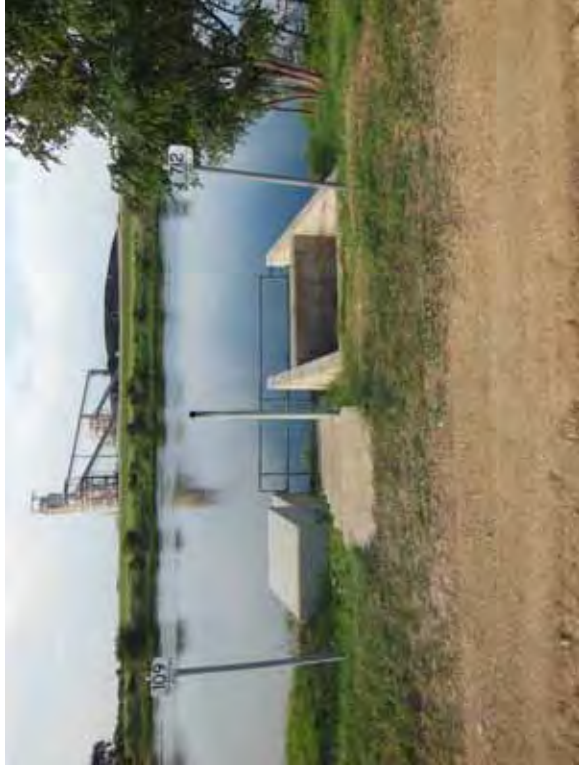
The outlet structure near the west embankment interior slope consists of two 18-inch-diameter steel outlet pipes, one is located in the north section of the pond and one is in the south section. The outlet pipes were submerged during the site assessment (Photographs 24 and 27). CCW is pumped through the outlet pipes to the clarifier located at the east embankment crest (Photograph 8). Liquids from the clarifiers are discharged to outfall 109 at the Plant intake canal (Photographs 55, 56, and 57).

Photo 57: SRH outfall 109, looking south.

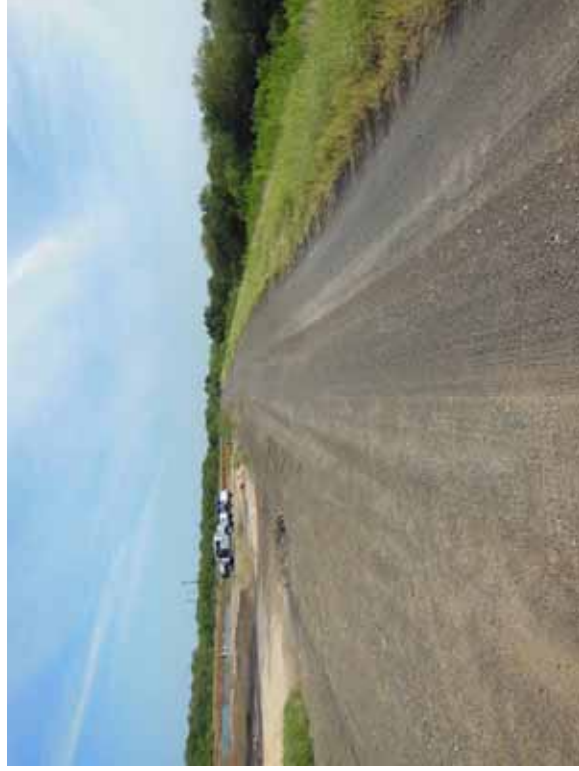
The embankment crest of the Evaporation Pond appeared to be in satisfactory condition (Photographs 58, 68, 76, and 82). The crest was approximately 15 feet wide at all embankments except the north embankment which measured approximately 50 feet wide. The crest of the embankment consists of a compacted gravel drive and grass. The surface is exposed to minimal vehicle traffic. No depressions or evidence of settlement were observed on the crest.

Photo 58: East Embankment crest, looking north.

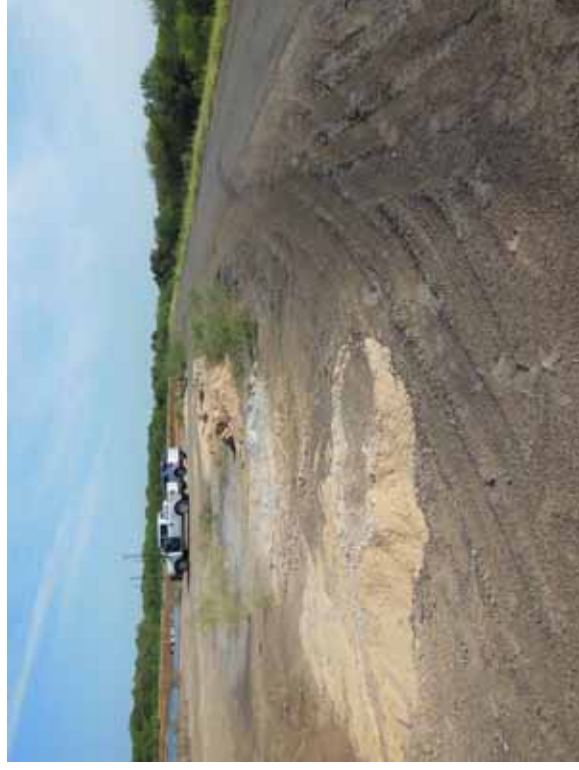
Due to the level of solids and water in the Evaporation Pond during the assessment, only the upper 0.5 to 2 ft of the interior slopes were visible (Photographs 59, 69, 70, 74, and 83). Vegetation covered some portions of the west and south embankment interior slopes (Photographs 79, 83, and 88). Ash and other solid material extend up to the crest near the southeast corner interior slope and on the east embankment interior slope (Photographs 59 and 90). Visible portions of interior slopes did not include riprap or other armoring.

Photo 59: East embankment interior slope, looking north.

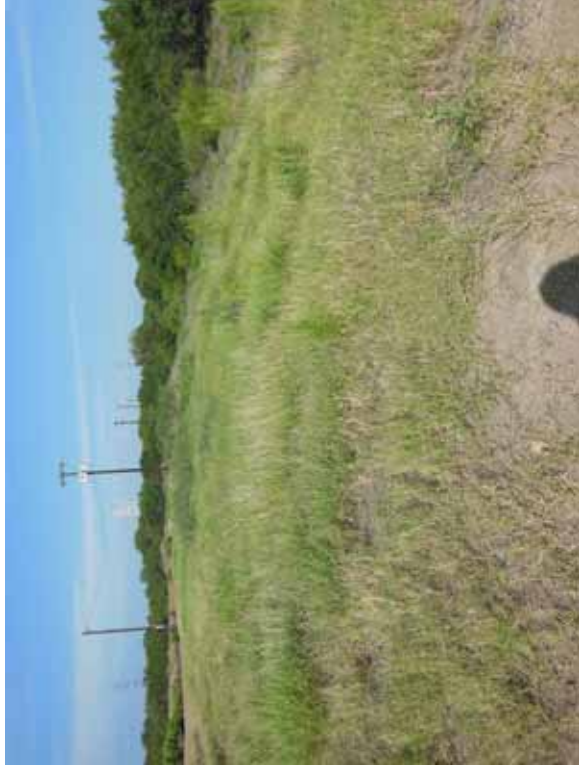
The exterior slopes appear to be in satisfactory condition and are covered in grassy vegetation approximately 2 feet high and a few small trees and bushes with diameters less than 6 inches in diameter (Photographs 61, 66, 77, and 87). Areas of loose soil were observed at the east embankment exterior slope (Photographs 60, 62, and 64) and an animal burrow was observed at the west embankment exterior slope (Photograph 78). An area of exposed soil was observed at the south embankment exterior slope (Photograph 85). Based on construction drawings, the exterior slopes are 3H:1V at all embankments, though slopes measured in the field ranged from 3H:1V to 4H:1V (Photographs 65 and 86). Trees up to 12 inches in diameter were located at the toe of all embankments (Photographs 63, 73, 80, and 87).

Photo 66: North embankment exterior slope, looking west.

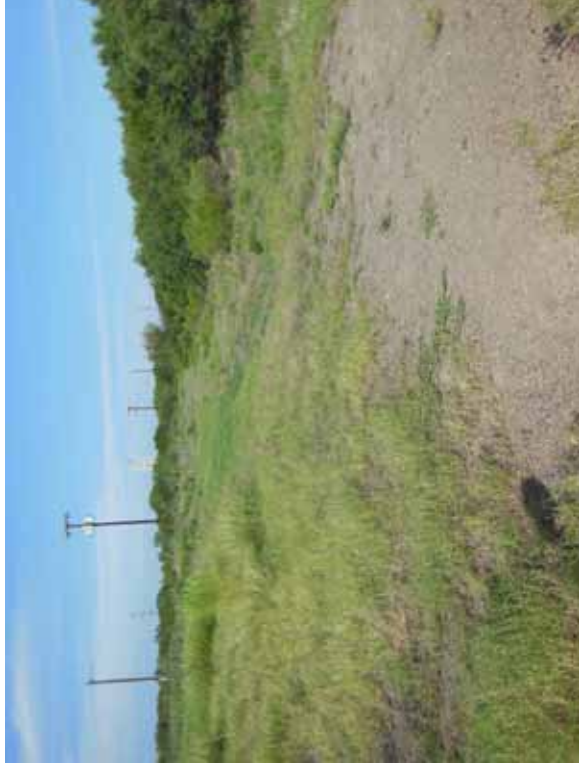
Photo 67: North embankment exterior slope, looking west.

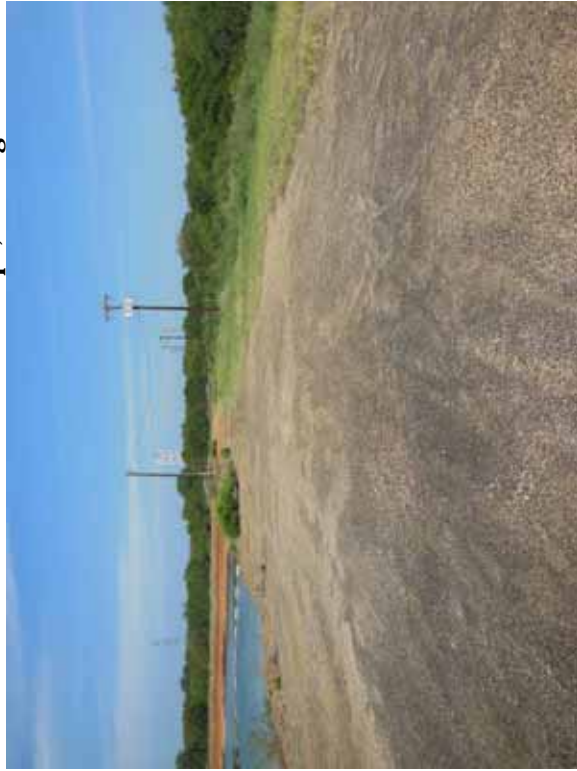
Photo 68: North embankment crest, looking west.

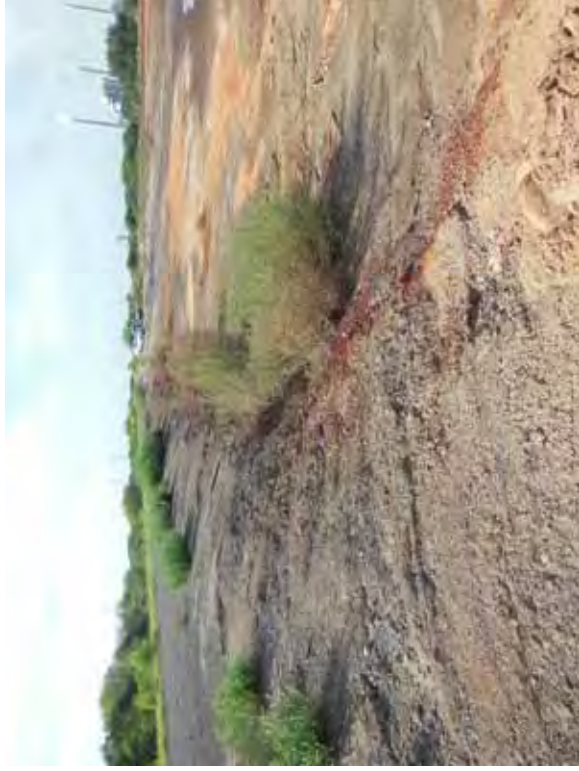
Photo 70: East embankment interior slope, looking south.

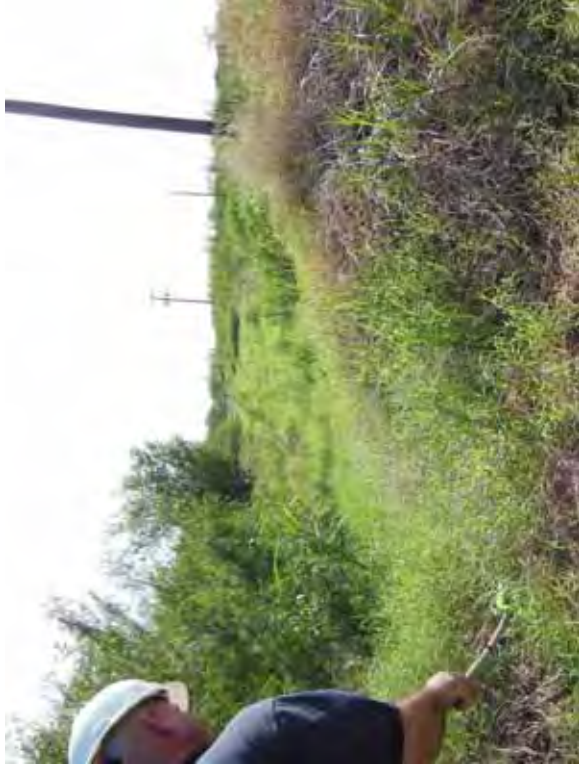
Photo 71: North embankment exterior slope, looking east.

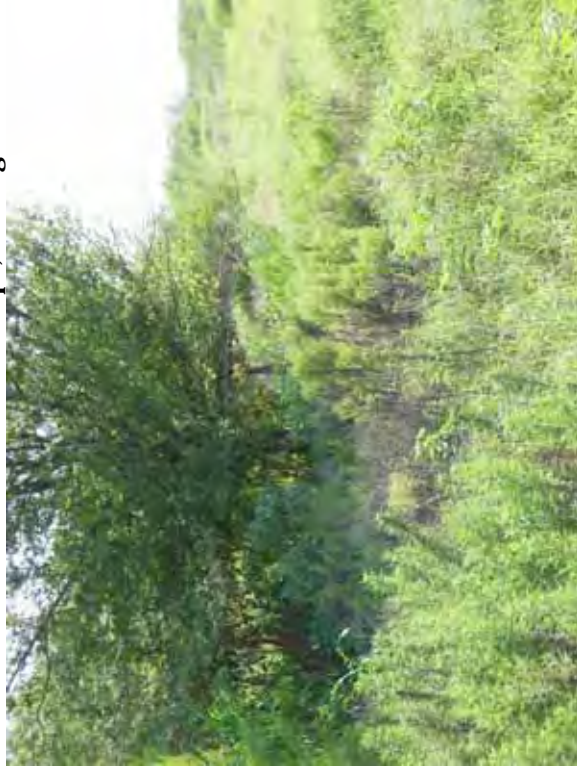
Photo 72: North embankment exterior slope, looking east. Note trees near exterior toe.

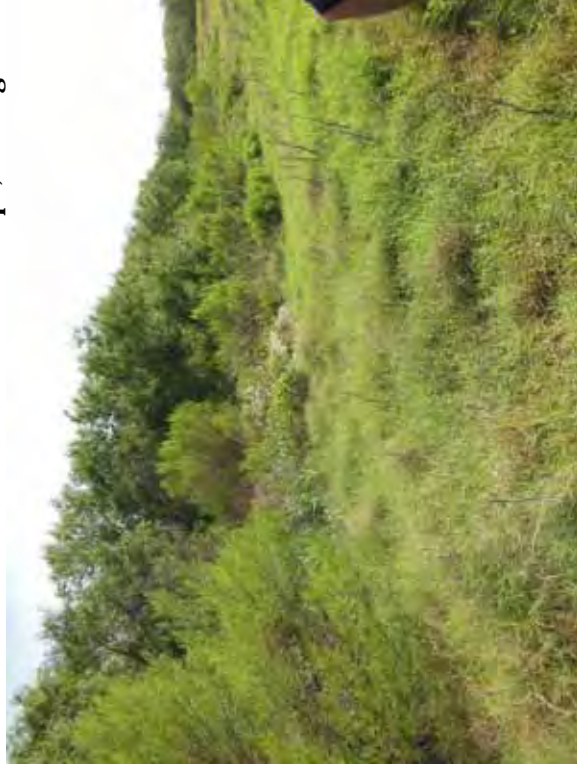
Photo 73: Trees at north embankment exterior toe, looking east.

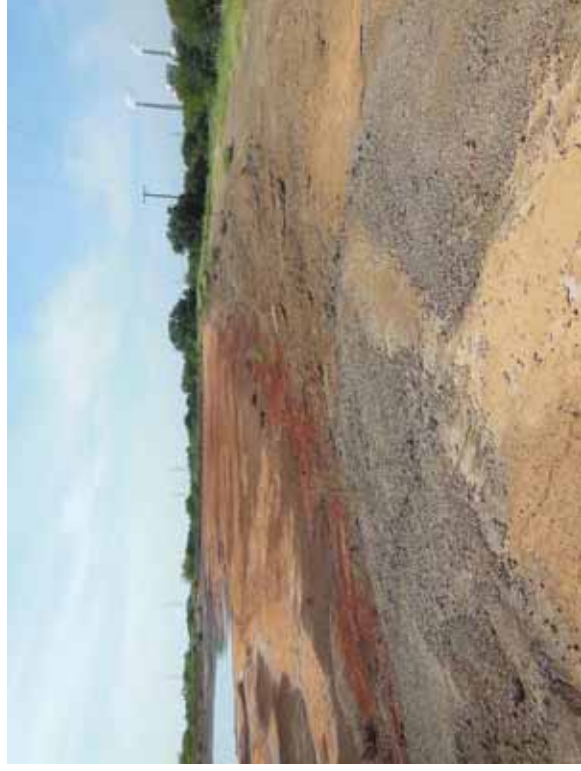
Photo 74: West embankment interior slope, looking south.

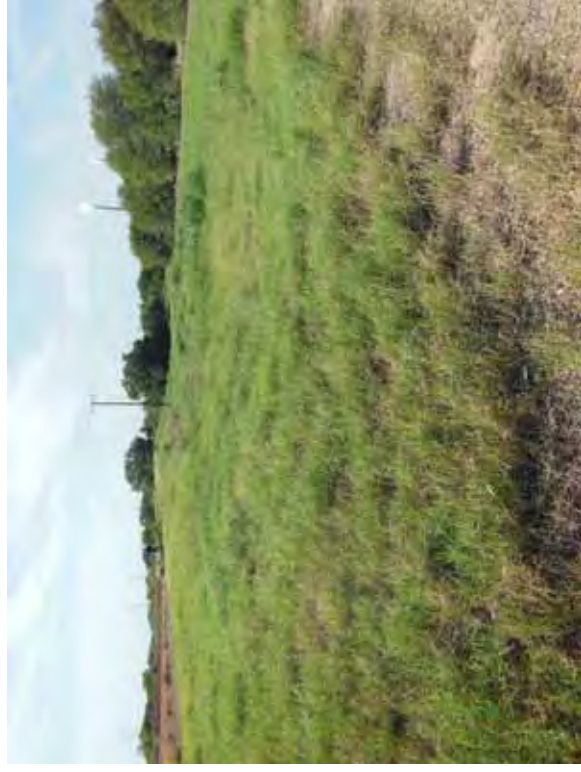
Photo 75: West embankment exterior slope, looking south.

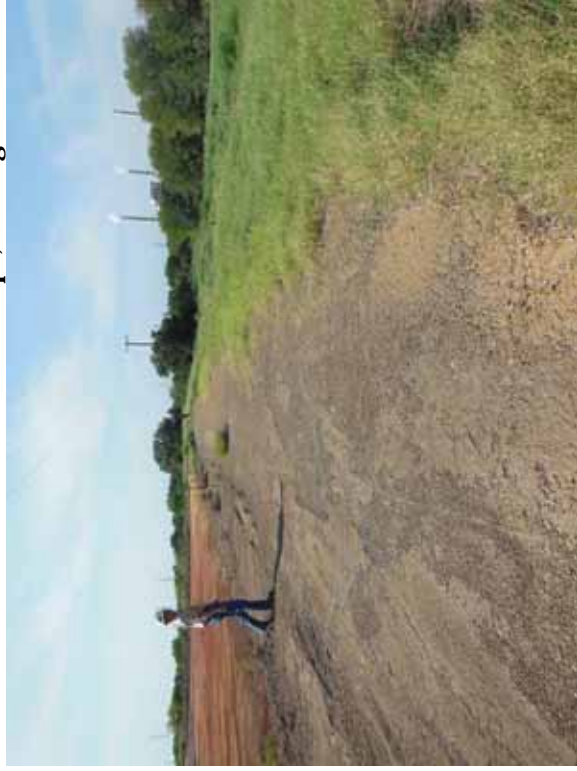
Photo 76: West embankment crest, looking south.

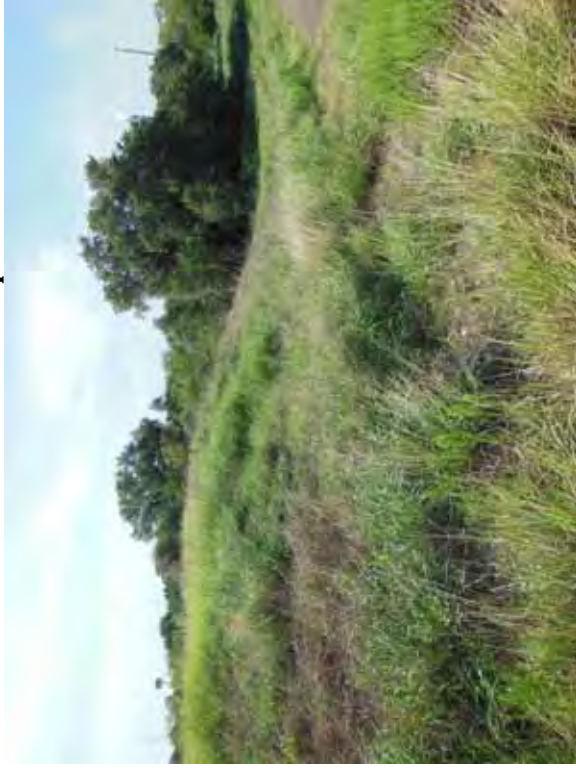
Photo 80: West embankment exterior slope, looking south.

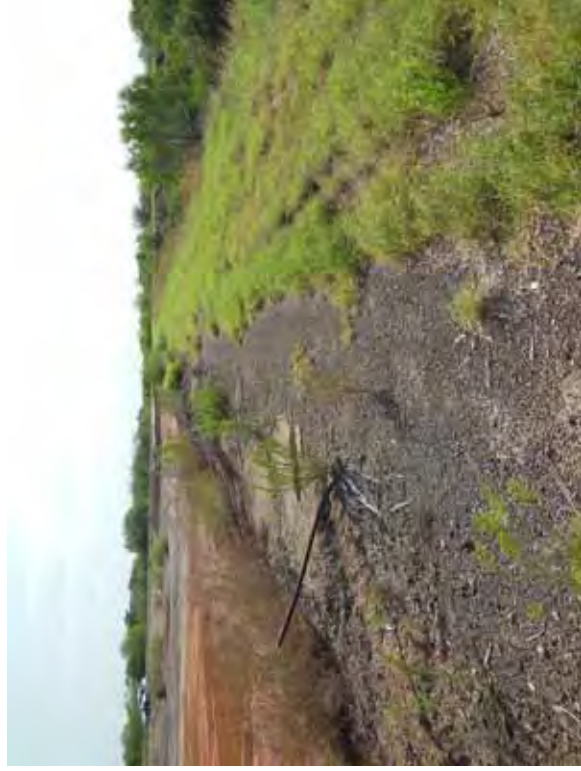
Photo 82: South embankment crest, looking east.

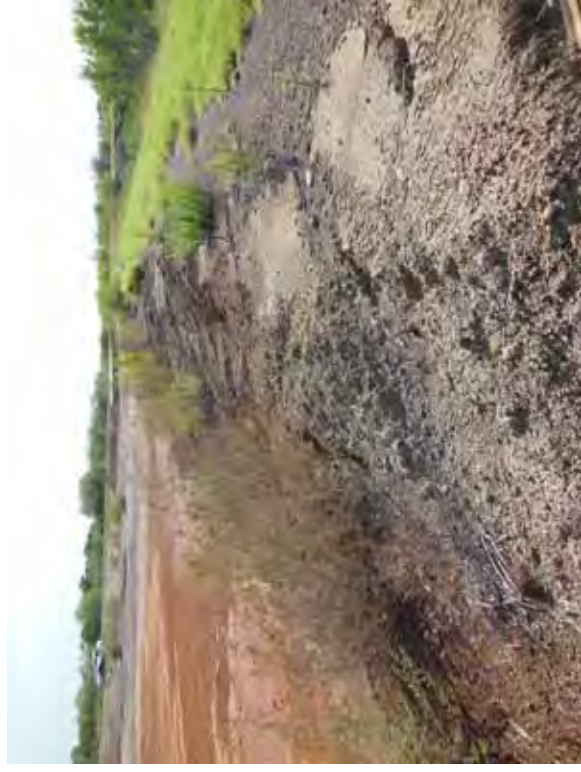
Photo 83: South embankment interior slope, looking east.

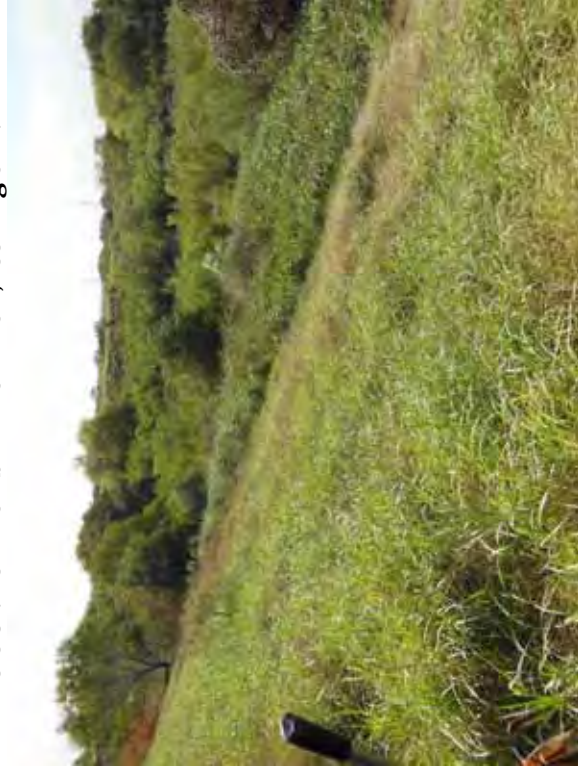
Photo 84: South embankment exterior slope, looking southeast.

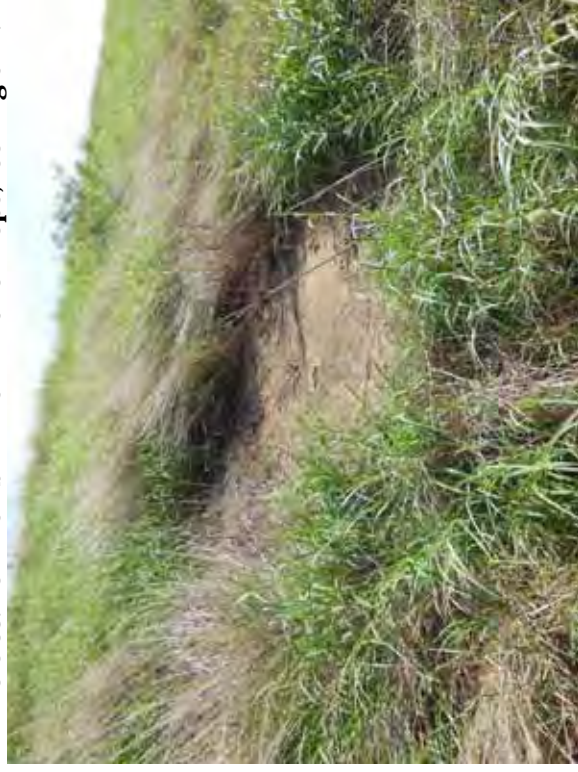
Photo 85: Exposed soil at south embankment exterior slope, looking north.

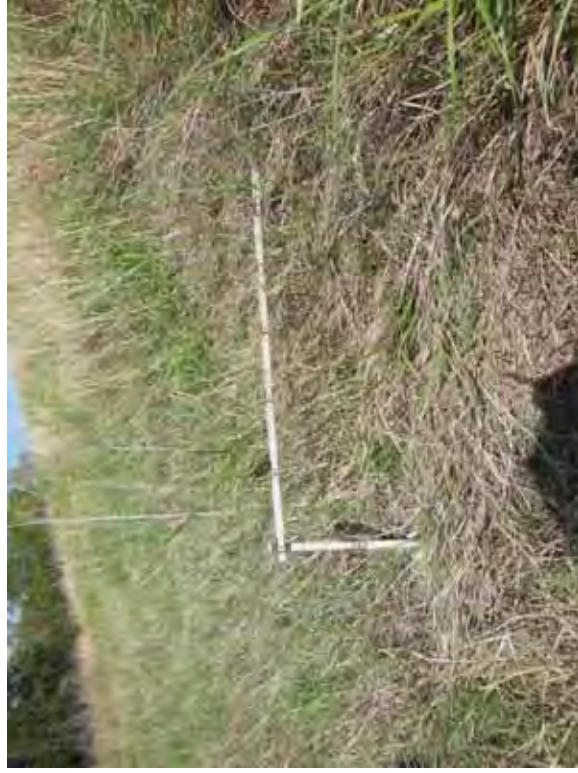
Photo 86: South embankment exterior slope measured approximately 3H:1V.

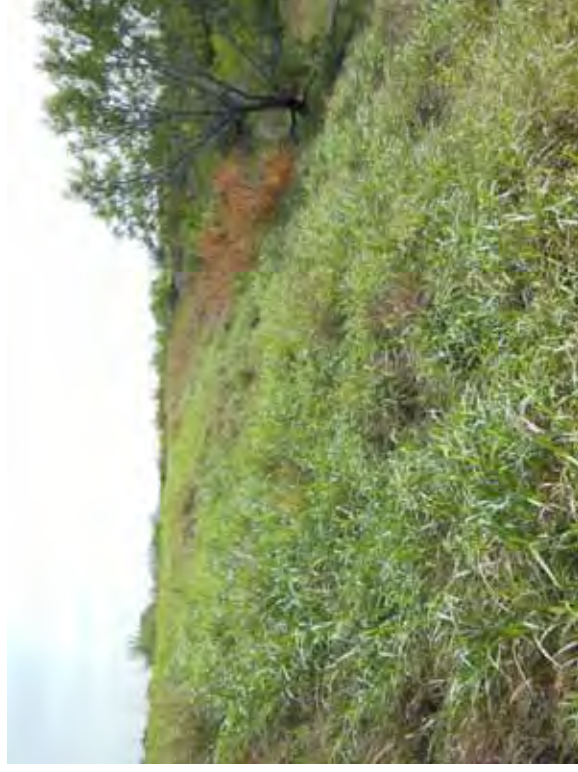
Photo 87: South embankment exterior slope, looking east.

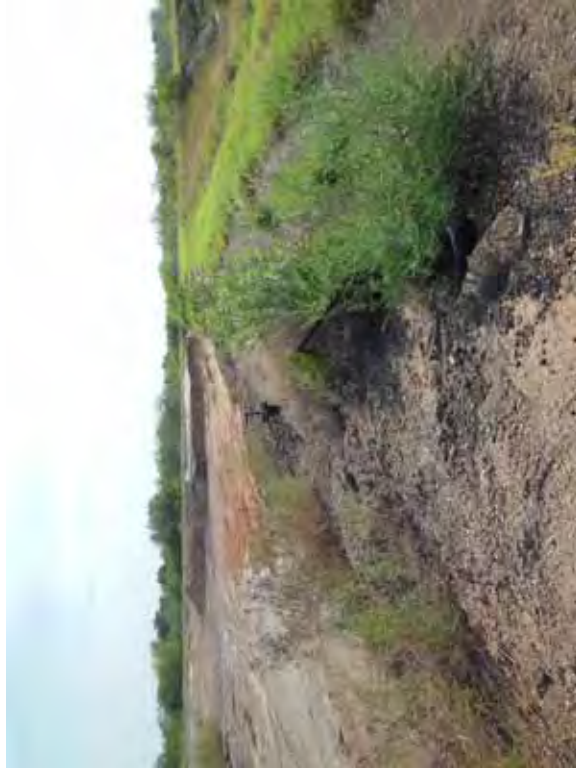
Photo 88: South embankment interior slope, looking east.

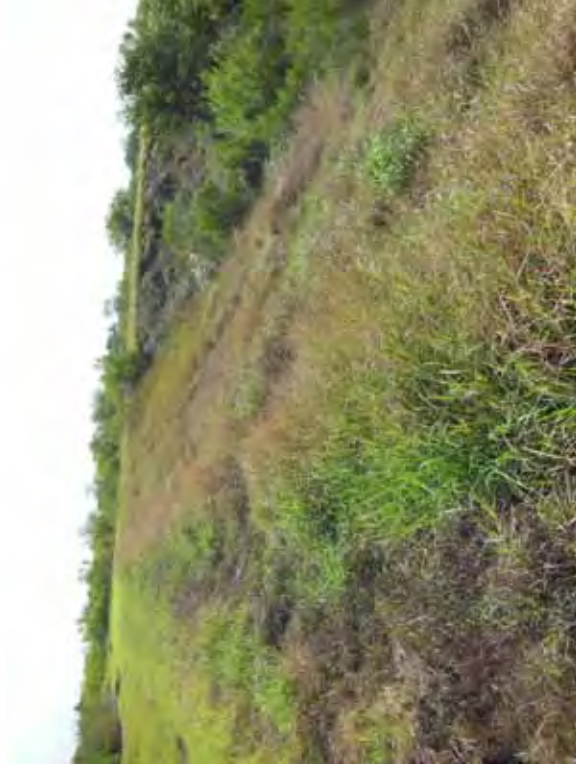
Photo 89: South embankment exterior slope, looking east.

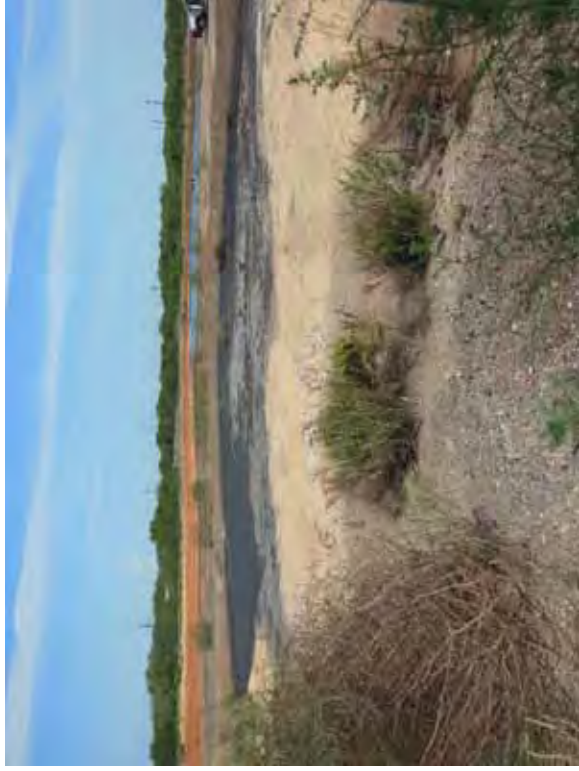
Photo 90: Interior slope at southeast corner, looking northwest.
